# ION THRUSTER SYSTEM (8-CM) CYCLIC ENDURANCE TEST

C.R. Dulgeroff, J.R. Beattie, R.L. Poeschel, and J. Hyman, Jr.

Hughes Research Laboratories  
3011 Malibu Canyon Road  
Malibu, CA 90265

Final Report

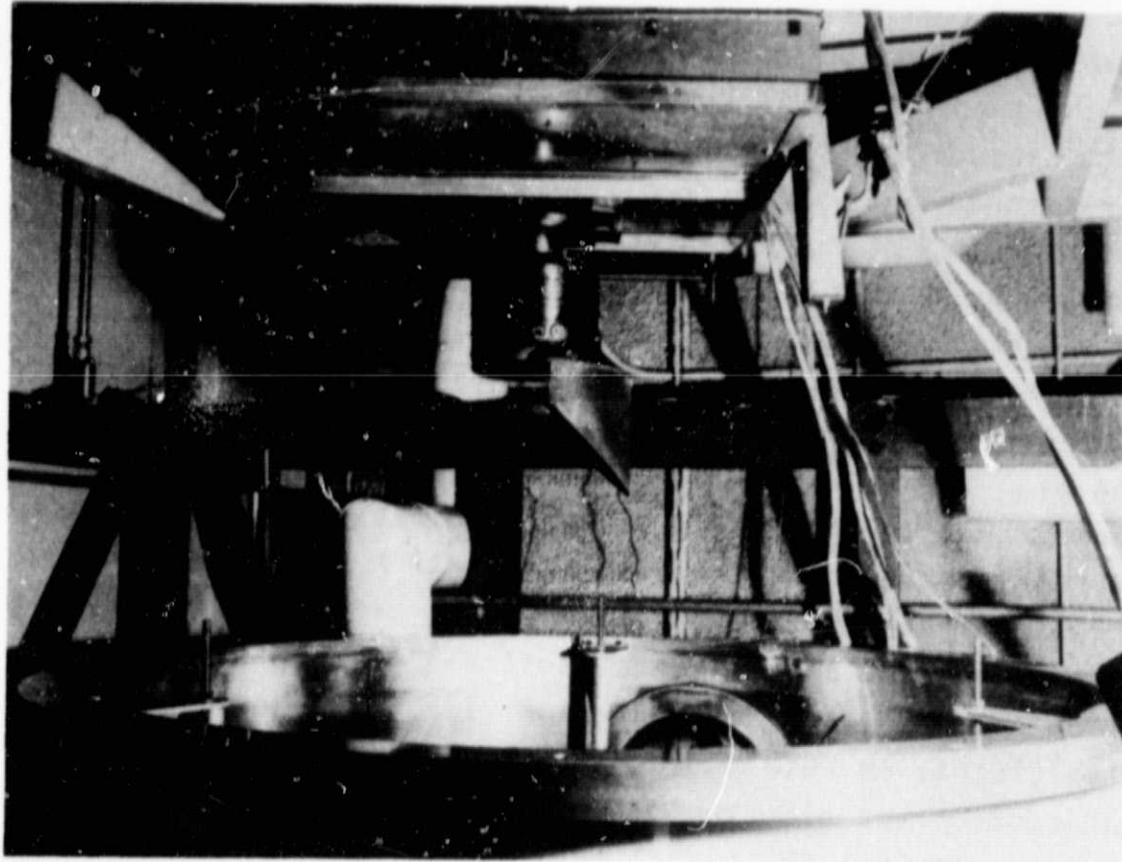
M14979

Figure E-2. Post-test appearance of the thruster and electronics module.

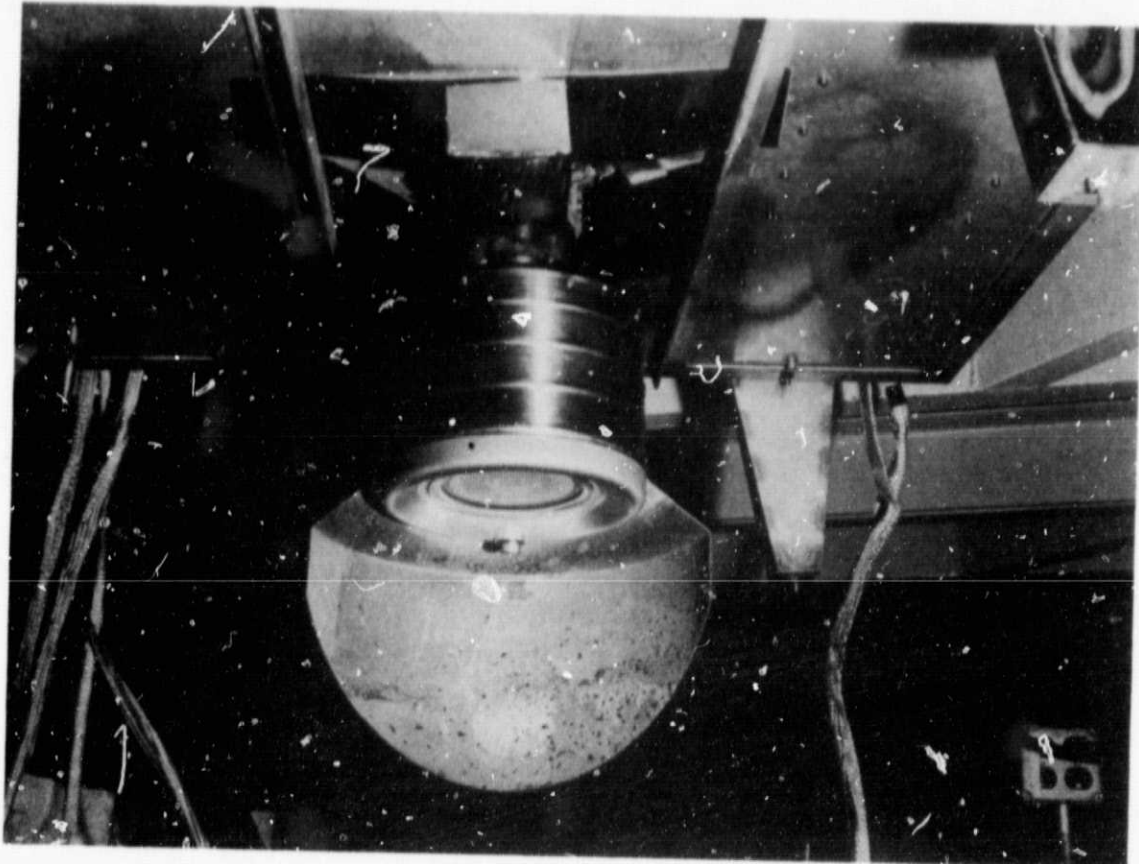
M14980

Figure E-3. Post-test appearance thruster.

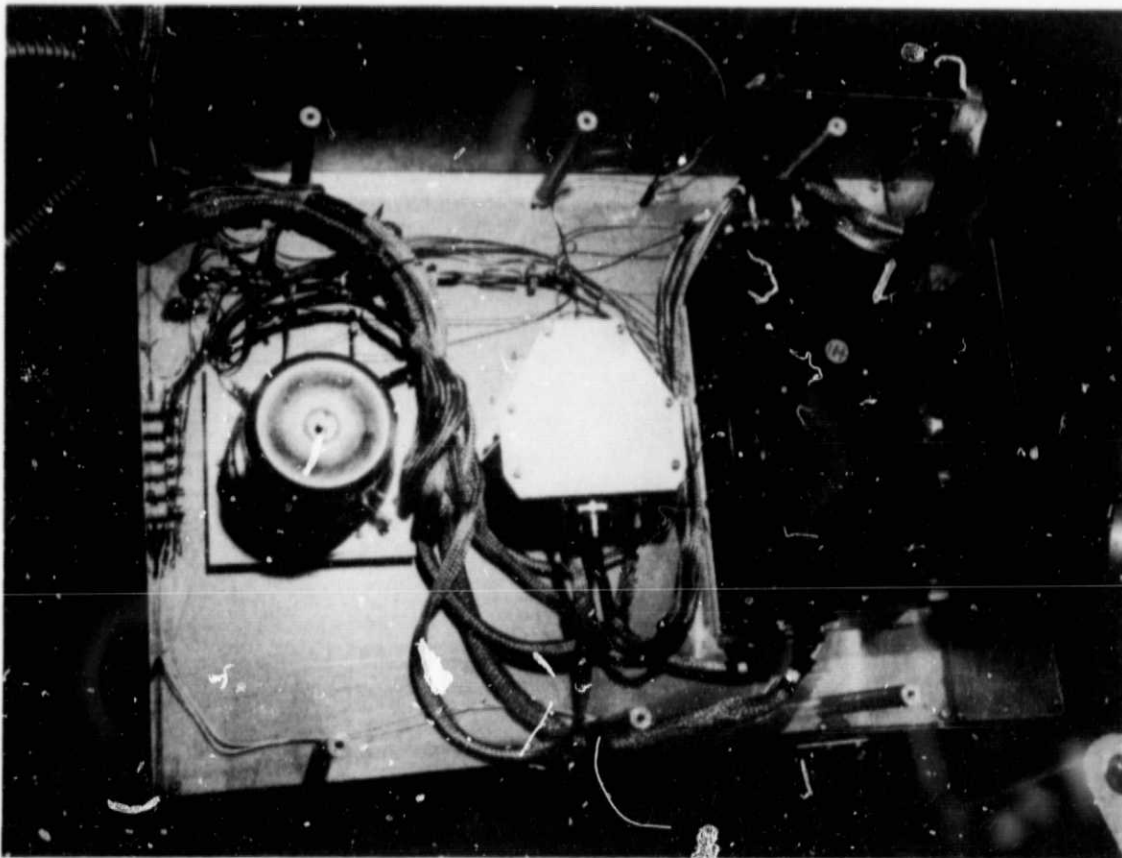
M14978

Figure E-4. Post-test appearance of electronic module with cover removed.

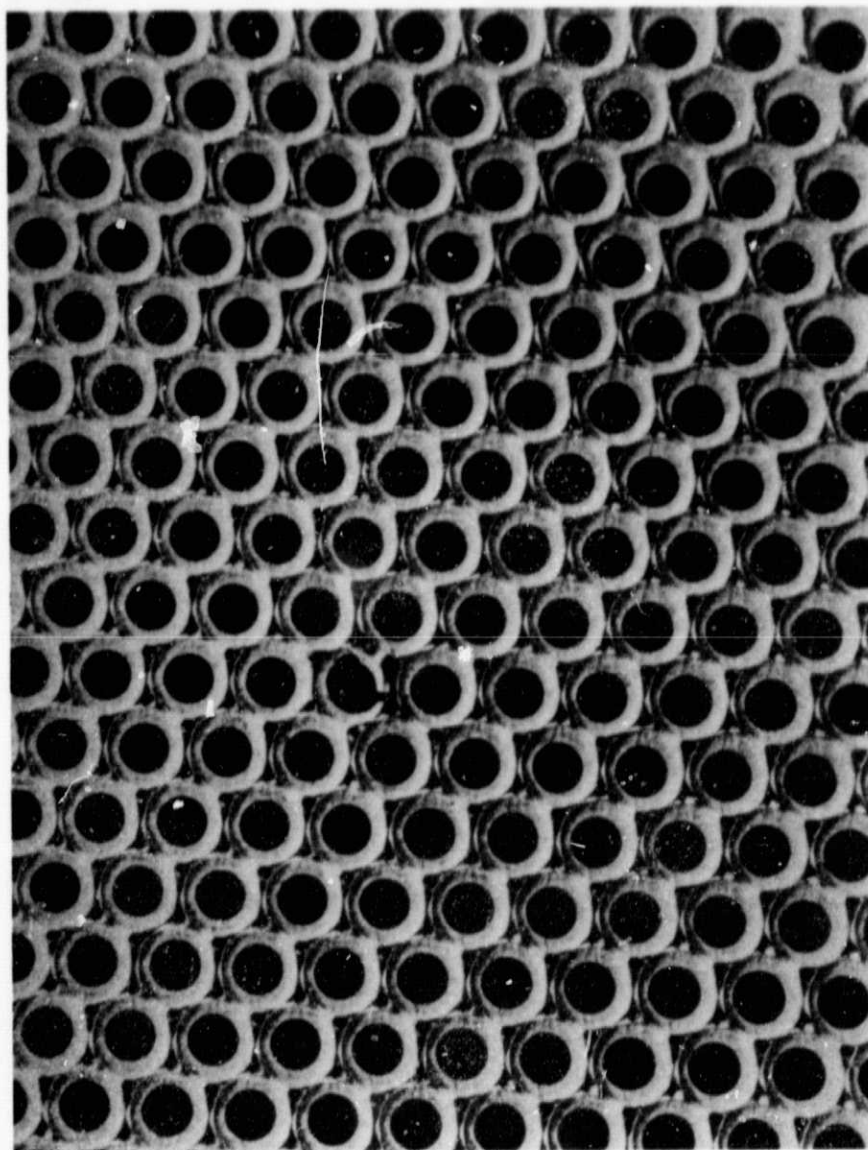
M14985

The major wear on the electrode assembly occurred in the accelerator grid. There are two sets of hole diameters in the accel grid. The centrally located holes had diameters of 0.045 in. (0.114 cm) at the start of the test, and they increased to a range of 0.046-to-0.050 in. (0.117 cm to 0.127 cm) in diameter. The outer holes had diameters of 0.033 in. (0.084 cm) at the start of the test, and they increased to 0.034 in. (0.086 cm) in diameter; the small holes near the edge had become non-circular. The post-test accel grid is shown in Figure 17. This increase in hole size decreases the

This abnormally high erosion rate was brought about by two abnormal conditions: (1) operation at  $V_0 = 25$  V, and (2) the passage of leaking mercury vapor across the downstream surface of the accel grid. These two abnormal conditions should not exist on the IAPS flight.

Figure E-8. Enlarged view of accel grid.

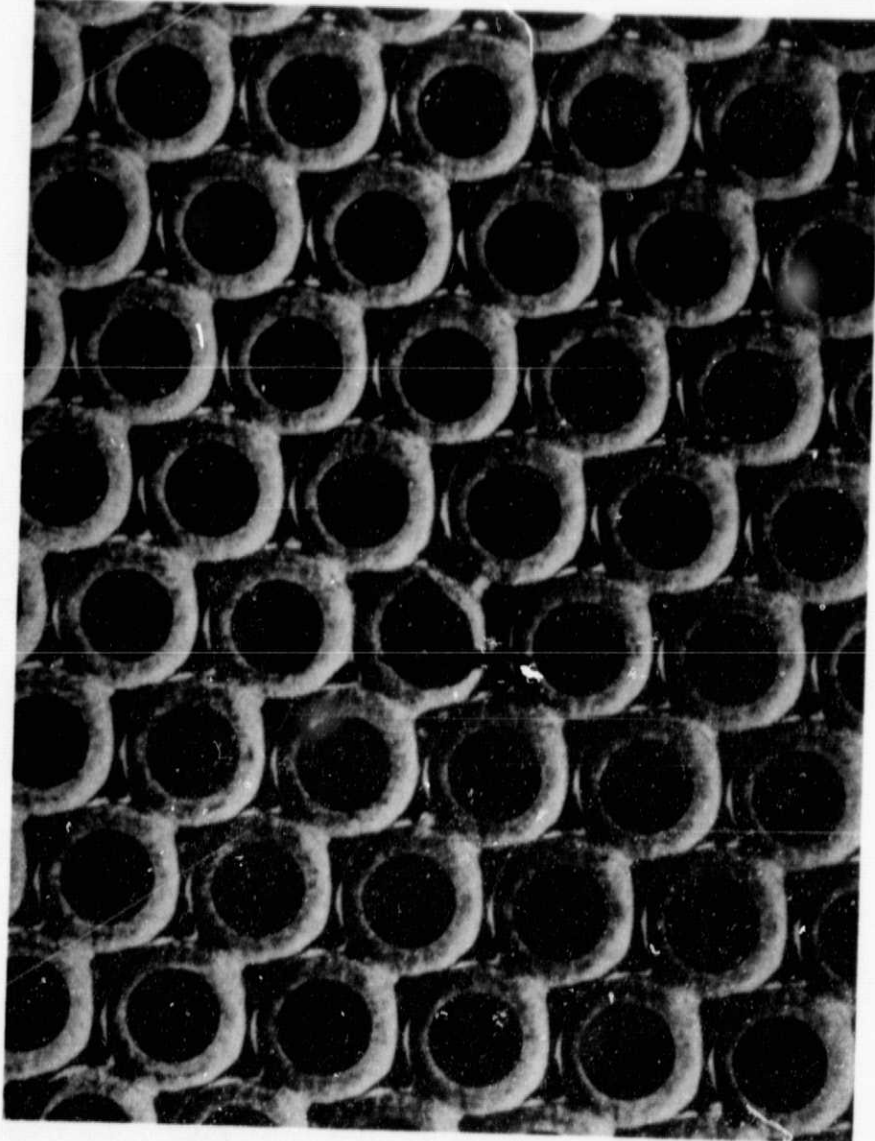
M14985

Figure E-9. Enlarged view of accel grid.

grid). These figures also provide additional detail on the eroded web near the center of the grid. Figure E-10 is a blowup showing the notching that occurs near the beam edge and the peculiar appearance of the aperture adjacent to the neutralizer (3 o'clock position, fourth aperture from the edge).

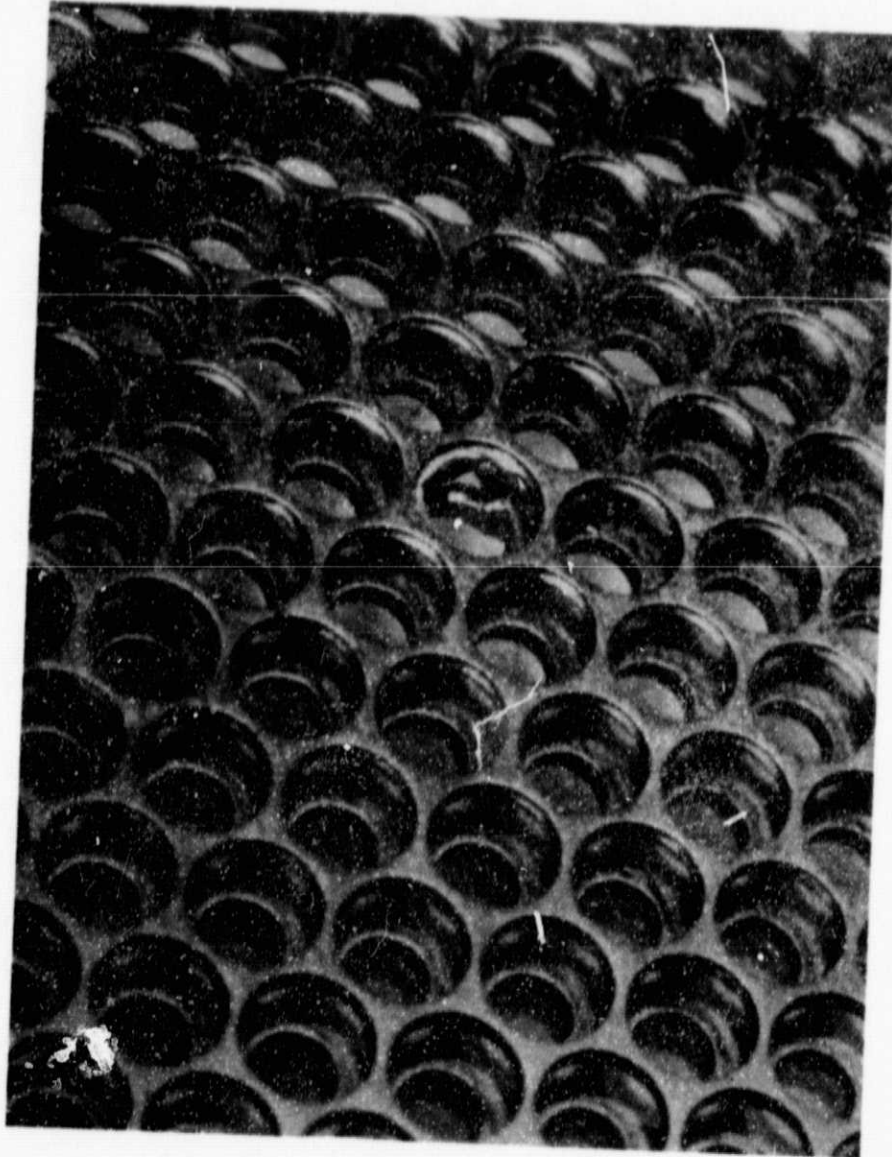
Figure E-11. Screen side of ion-extraction assembly.

Figure E-11 is a photograph taken from the screen side of the ion-extraction assembly, showing the damaged accel aperture near the center of the electrode. Close examination of the adjacent screen aperture shows a buildup of material, apparently caused by deposition of material sputtered from the accel grid. Also, the small white spots that appear just below the top edges of some of screen apertures are those locations where the accel grid was eroded all the way through. Figures E-12, E-13, and E-14 are additional photos showing the appearance of the accel grid (taken from the screen-grid side). Figure E-15 is a photo taken from the same orientation, showing a peculiar "crater" near the (bottom) edge of one of the central screen apertures. Figure E-16 shows details of the accel-aperture notching that was prevalent near the edge of the aperture pattern. The accel aperture in the center of this photo can be seen to be bridged by a slender piece of material -- one of the foreign objects that was collected.

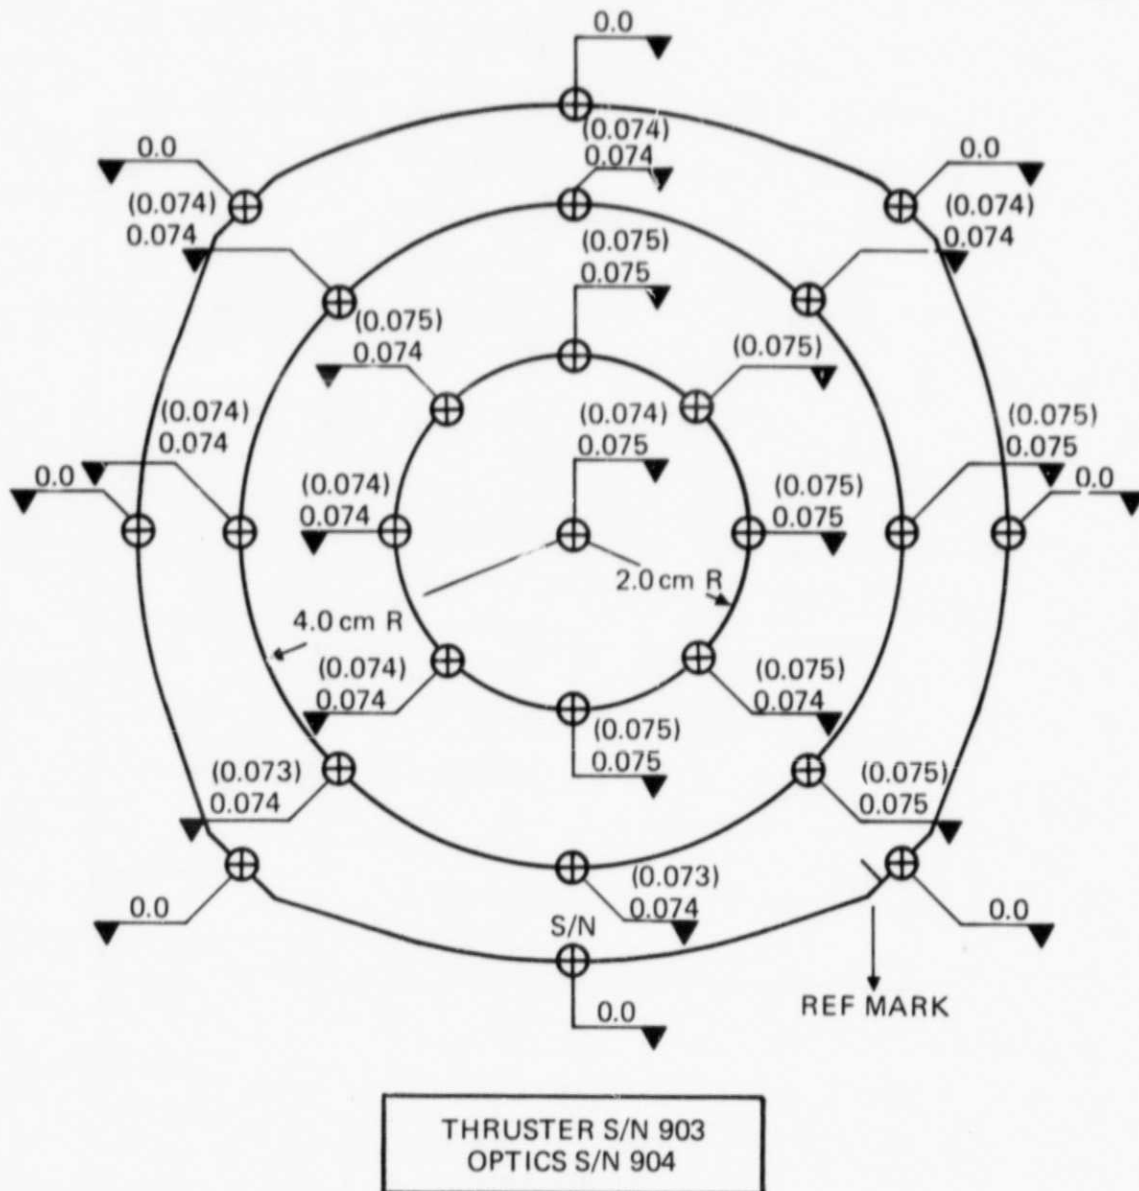
Figure E-17. Pre-test and post-test screen aperture dimensions (inches). Post-test values in parenthesis.

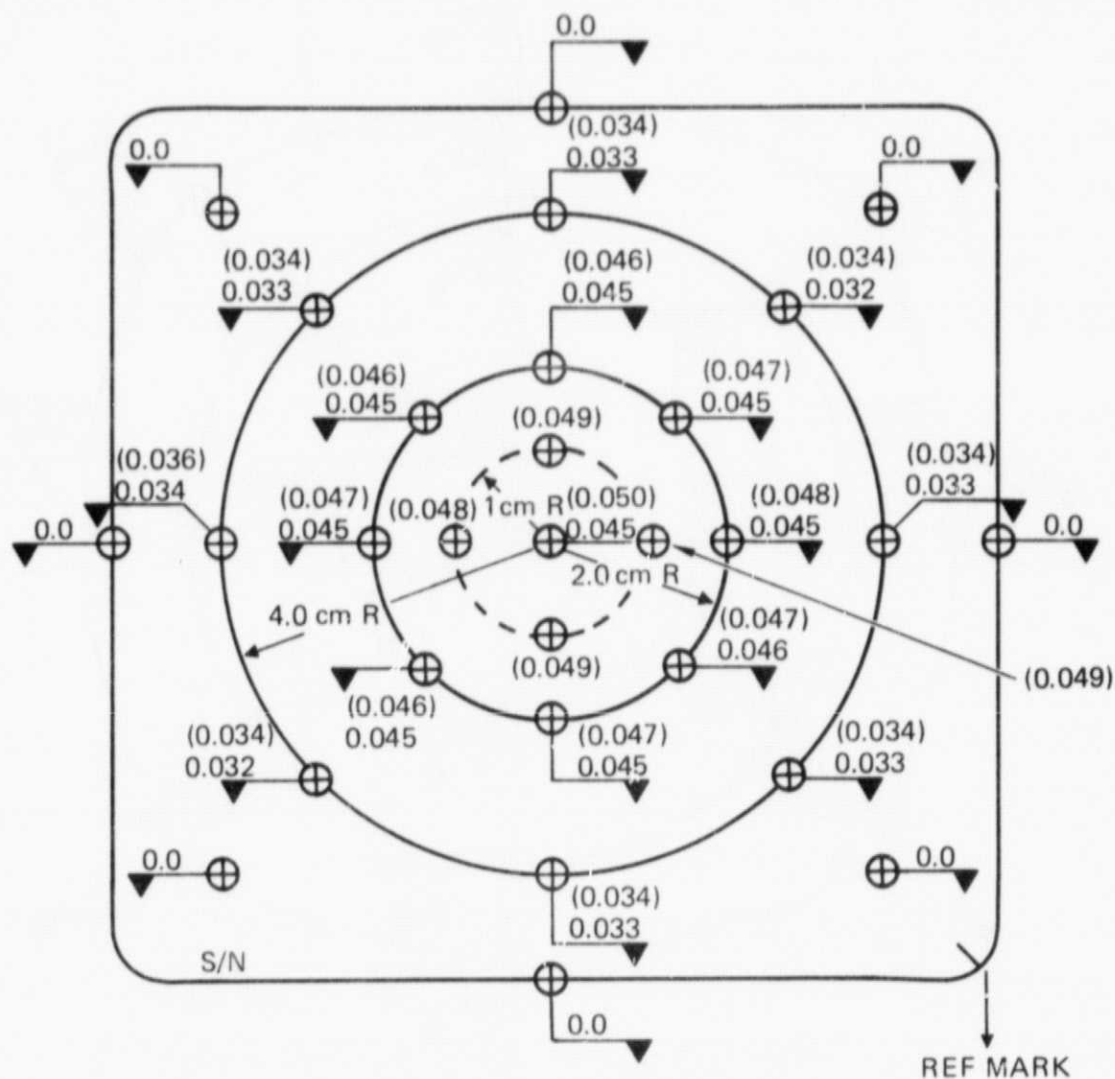
Figure E-18. Pre-test and post-test accel dimensions (inches). Post-test values in parenthesis.

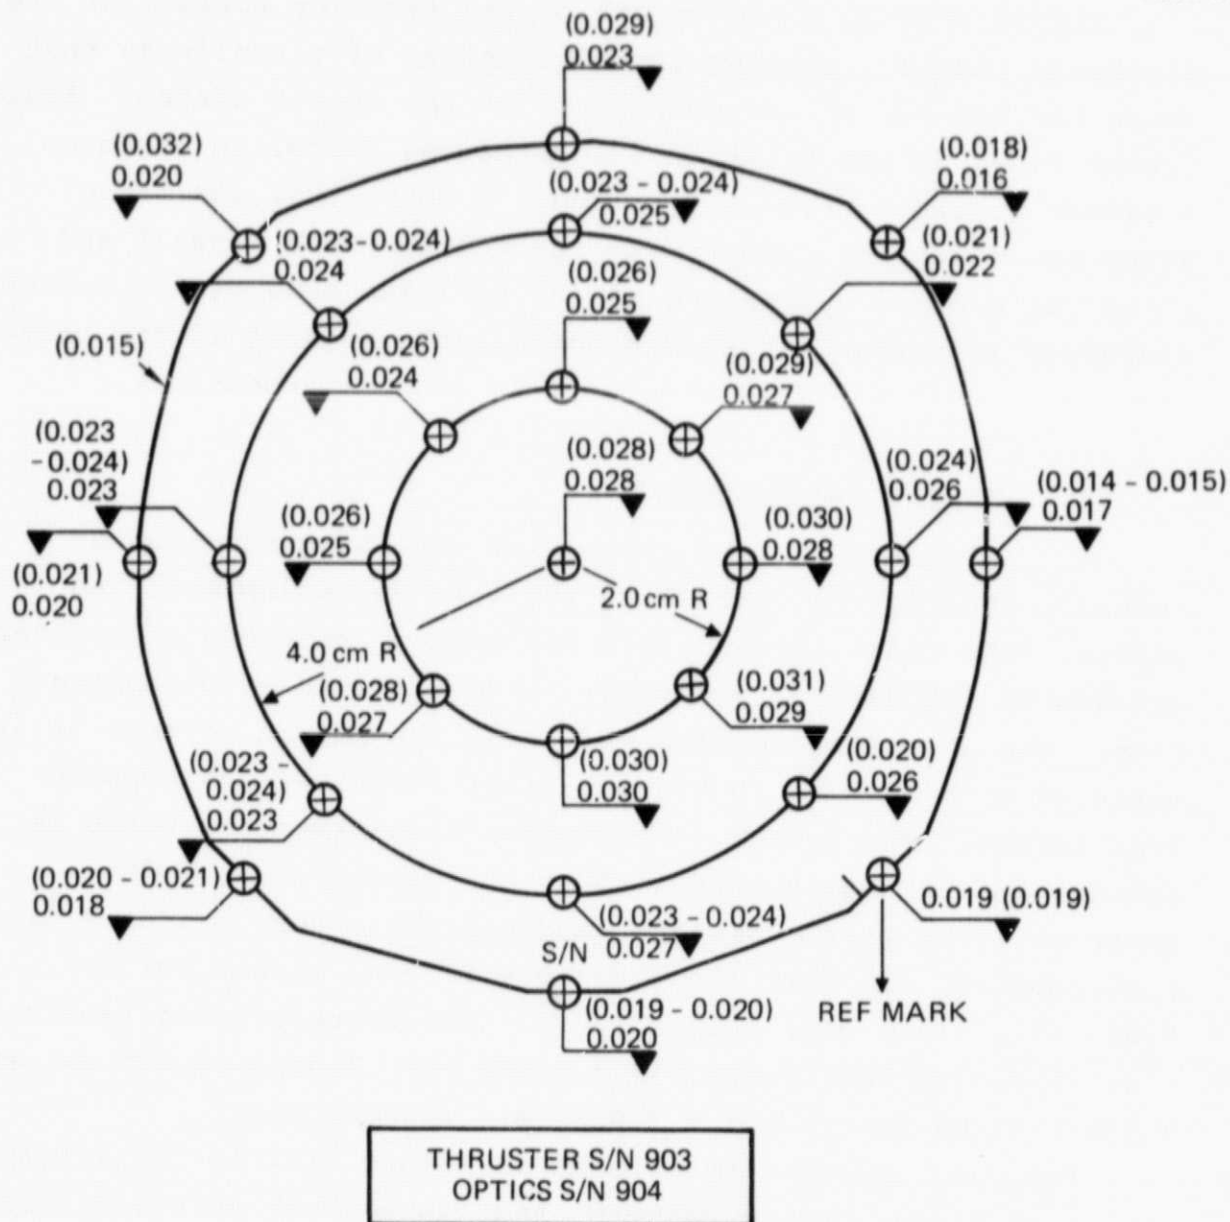
Figure E-19. Pre-test and post-test screen accel spacing (inches). Post-test values in parenthesis.

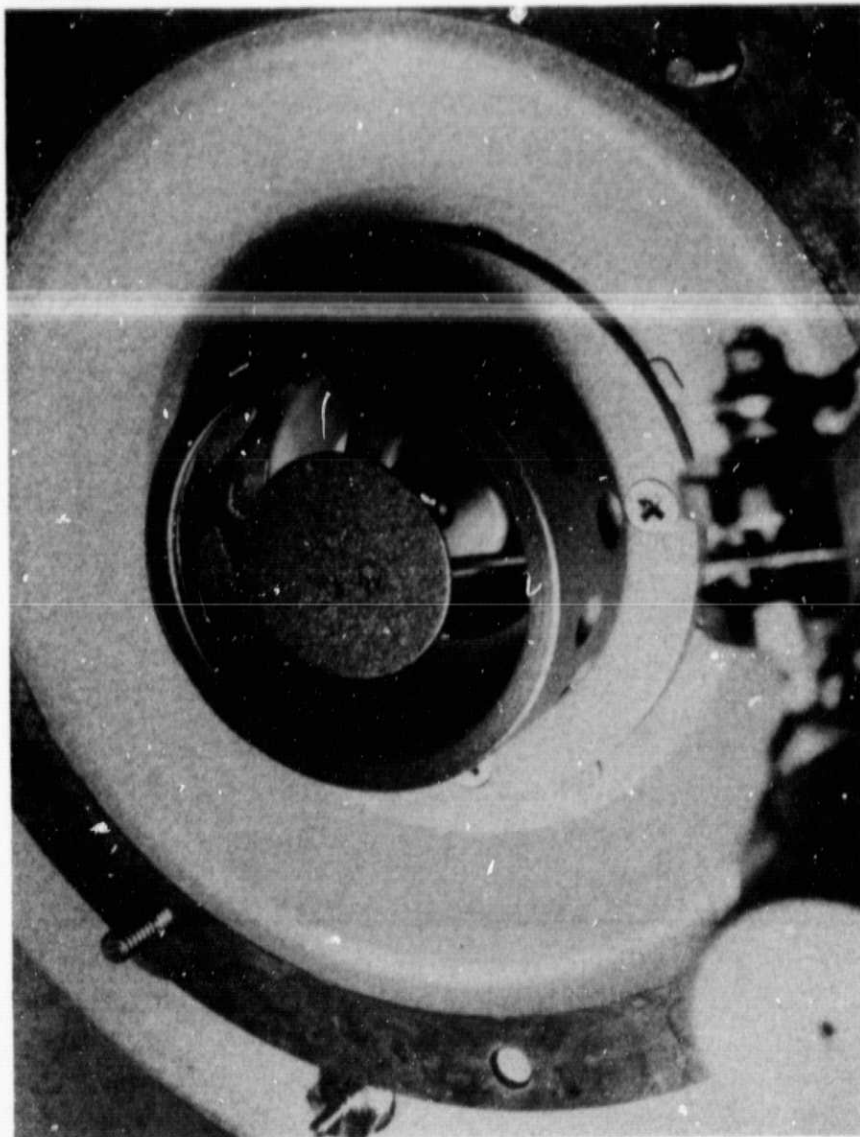
Figure E-22. Post-test appearance of discharge chamber endwall, cathode cup pole piece and baffle.

Figure E-22 is a closeup of the discharge-chamber endwall, showing the details of the cathode, polepiece, and baffle. The flame-sprayed surfaces show no evidence of sputter erosion or deposition, and there is no evidence of discoloration. The appearance of the baffle is considered normal; it is centered with respect to the polepiece, with all the support legs intact. The screen covering the flow-diversion ports is intact, and nothing abnormal about the discharge cathode is apparent. The baffle diameter and thickness were measured using a micrometer, and were found to be 0.811 in. (2.060 cm) and 0.025 in. (0.064 cm), respectively. The corresponding fabrication specifications are  $0.813 \pm 0.002$  in. ( $2.065 \pm 0.005$  cm) and  $0.030 \pm 0.003$  in. ( $0.076 \pm 0.008$  cm), respectively.

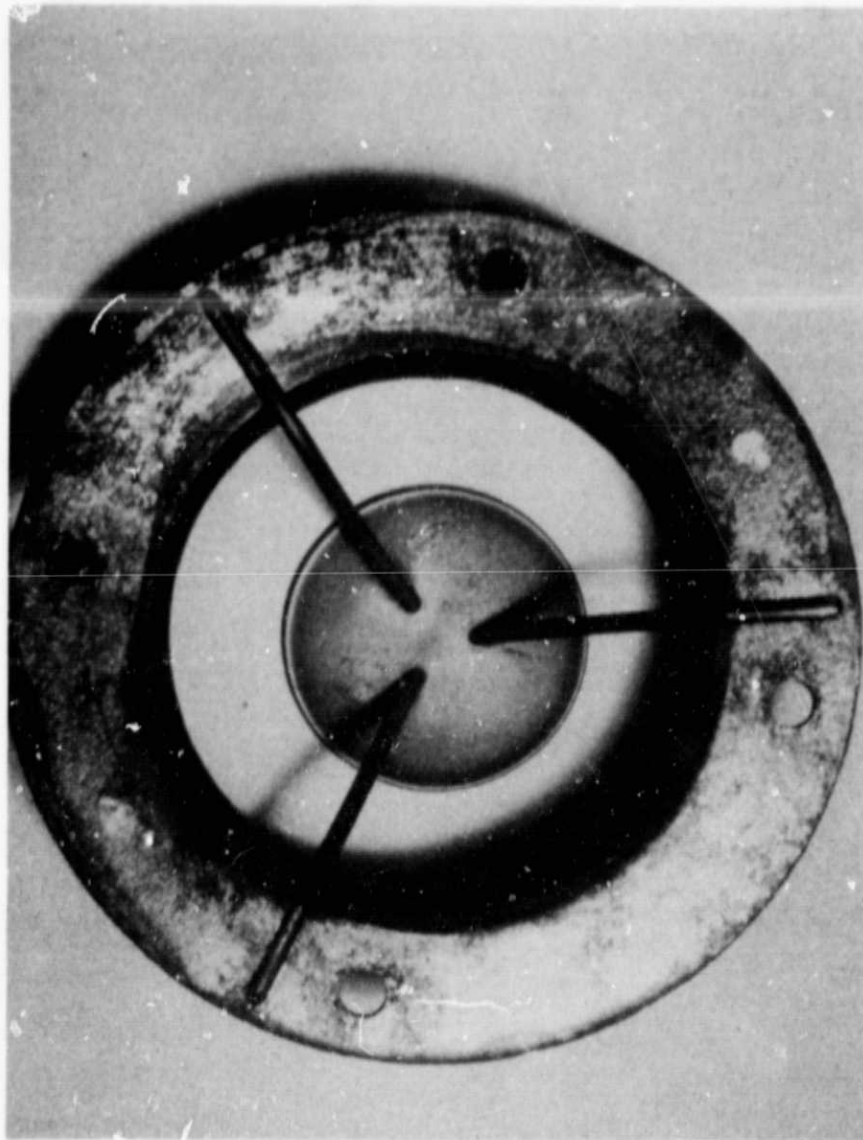
Figure E-25. Post-test appearance of upstream side of baffle assembly.

The appearance of the upstream side of the baffle and its support legs is illustrated in the photo of Figure E-25. No unusual features are apparent. The diameter of the baffle-support legs was measured at several locations using a micrometer and was found to be 0.044 in. (0.124 cm) (fabrication specifications are  $0.050 \pm 0.002$  in. or  $0.127 \pm 0.005$  cm).

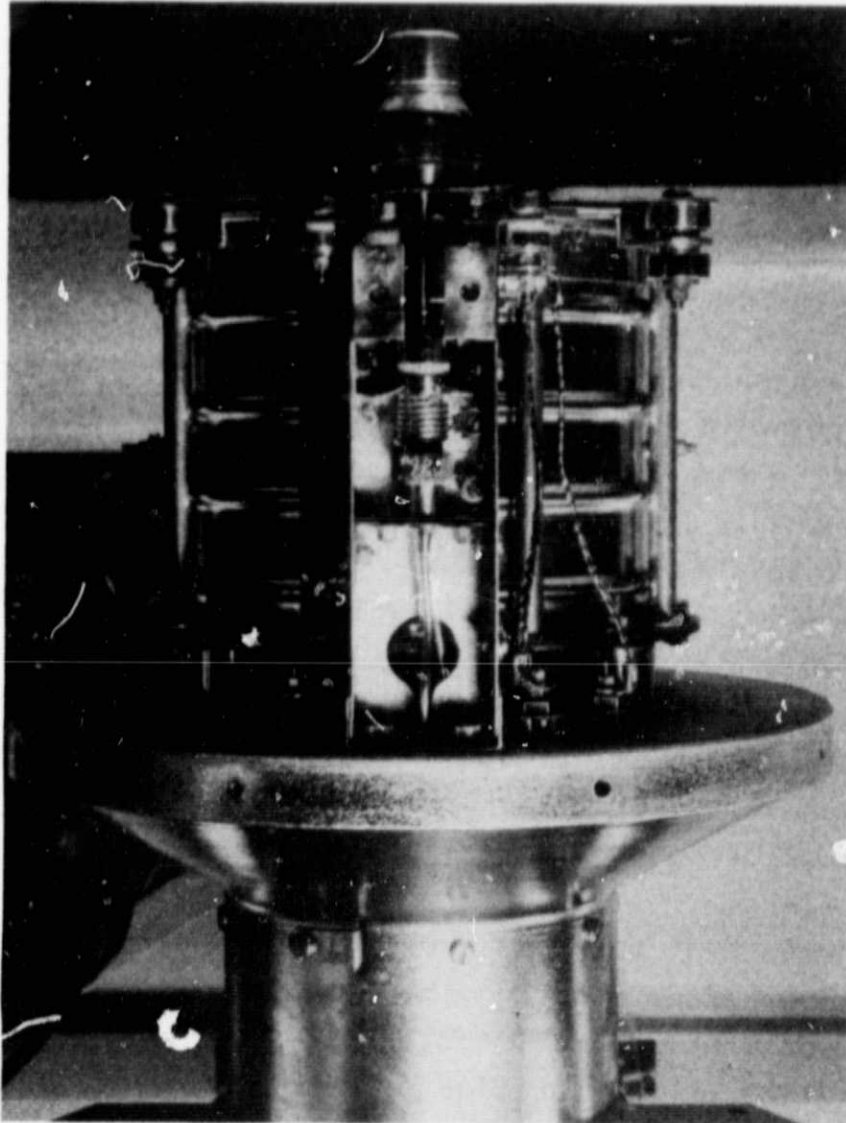
Figure E-29. Post-test appearance of neutralizer assembly.

Figure E-29 shows the appearance of the neutralizer assembly. The only abnormality noted was the appearance of the braided keeper lead, which was discolored and suggested an excessive keeper current was drawn at some point after assembly. The keeper lead was the only electrical lead that was discolored, and the contrast between it and the other current conductors was quite noticeable (cf the neutralizer keeper and heater leads of Figure E-29. Figure E-30 is a closeup of the neutralizer-feedline transition, showing that the braze joint is "drawn in", but there is no evidence of a crack at the juncture. The discoloration of the keeper lead is also apparent in this photo.

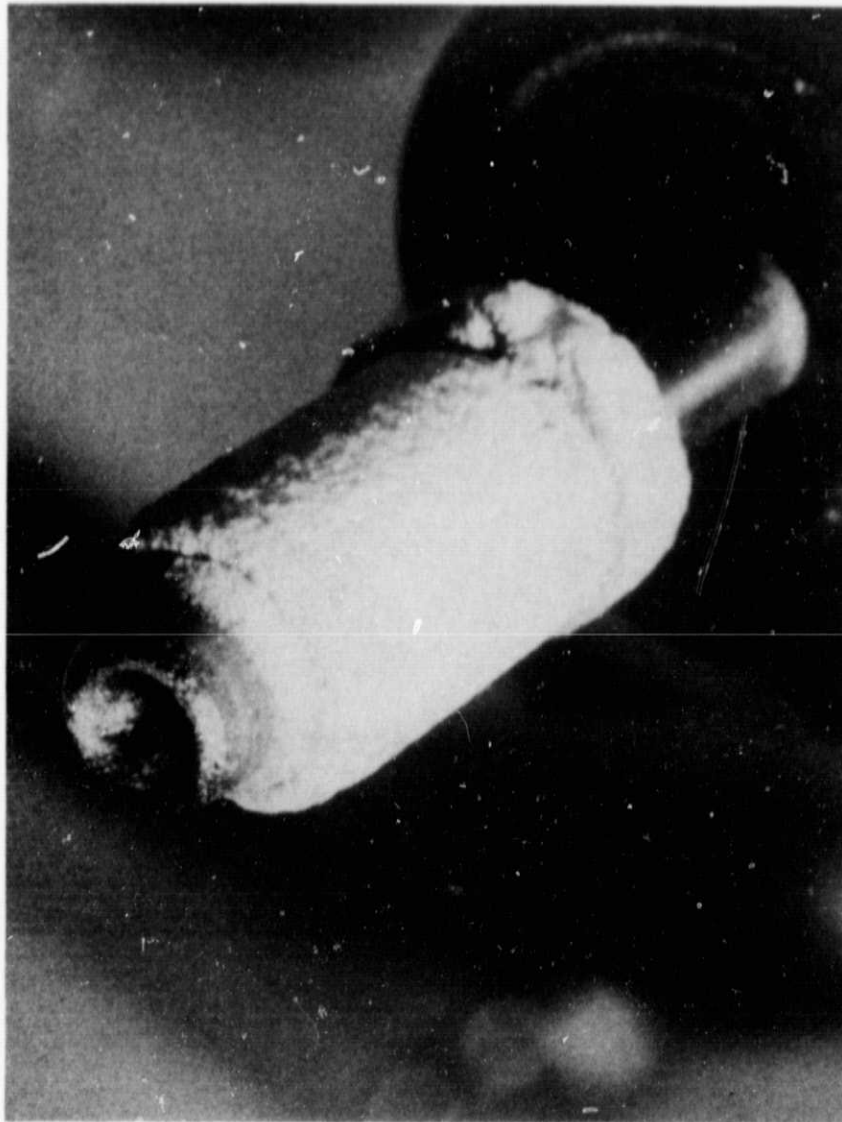
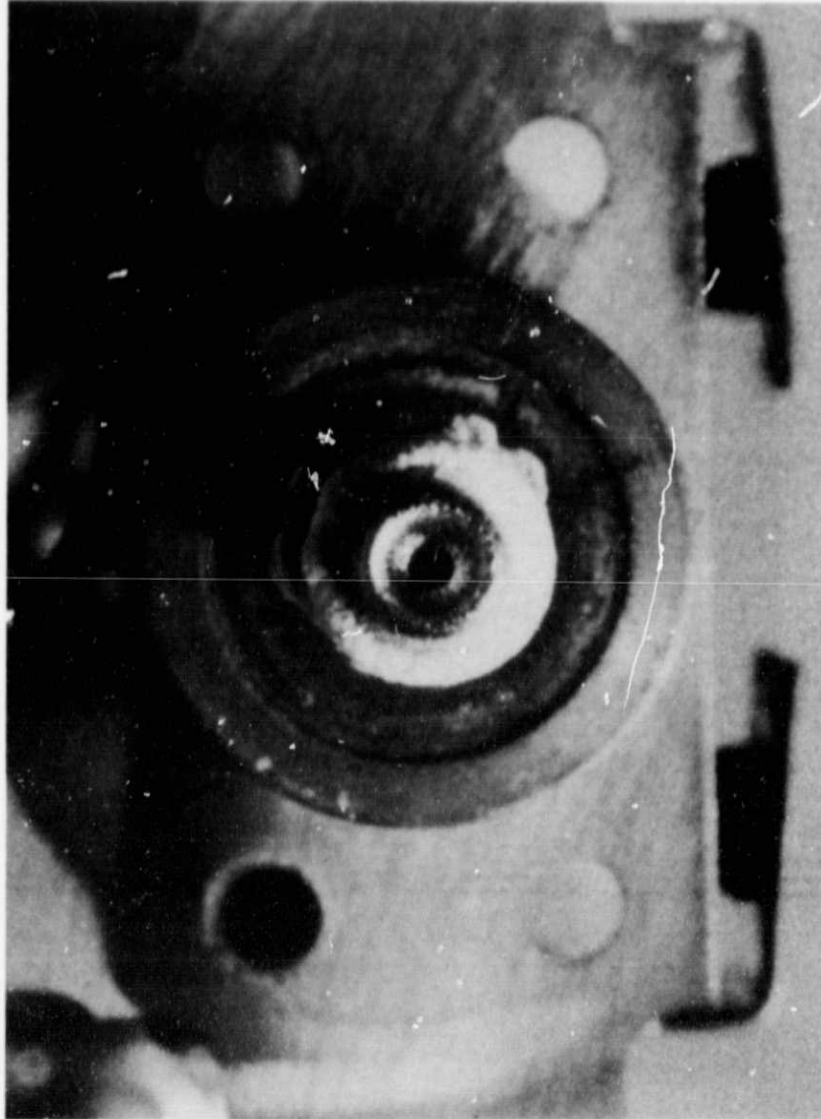
Figures E-32 and E-33 show the appearance of the neutralizer cathode after removing the keeper. The flame-sprayed alumina was "snow-white", and only a few very-fine cracks were evident. The cathode orifice plate did show signs of significant erosion, however, and the cylindrical throat region of the orifice plate was no longer visible. The shape and dimensions of a newly fabricated component are presented in Figure E-34a. Figure E-34b presents the results of measurements performed using a micrometer and plug gages to determine the indicated dimensions of the orifice plate, and upon comparison, it is apparent that the neutralizer orifice has undergone substantial erosion.

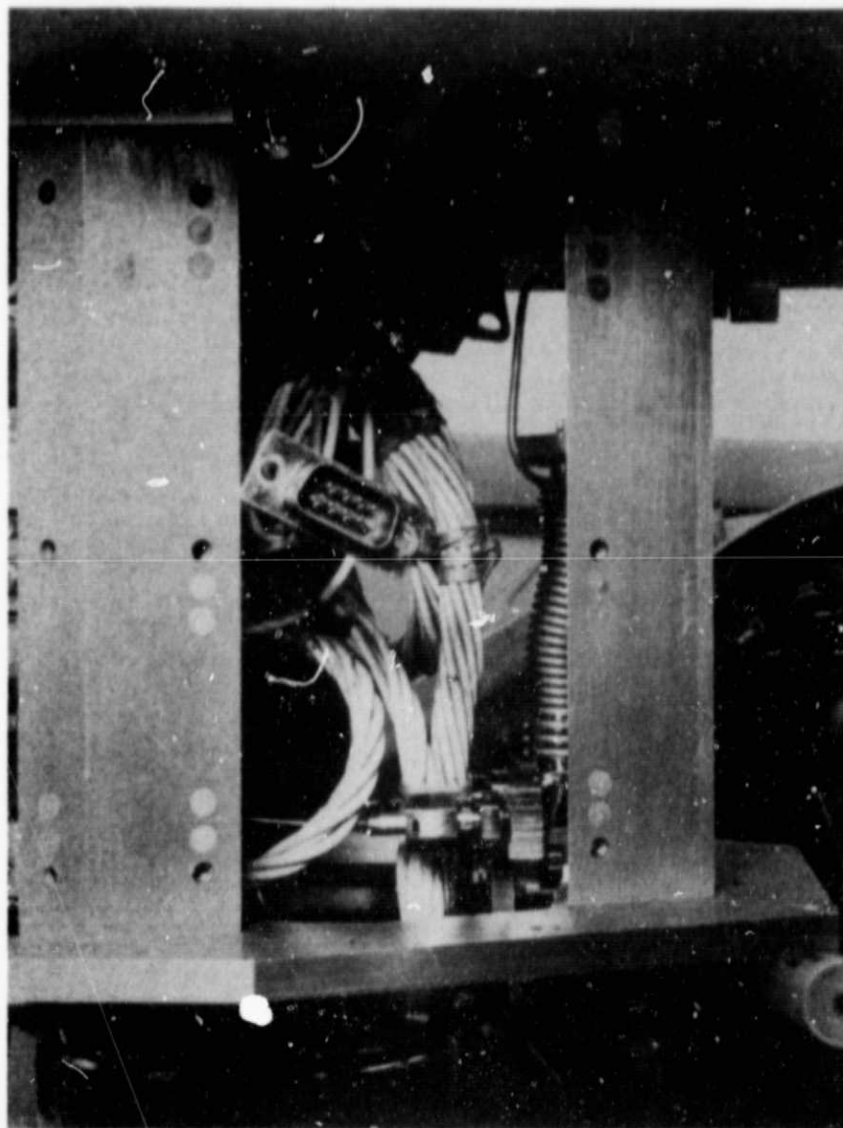
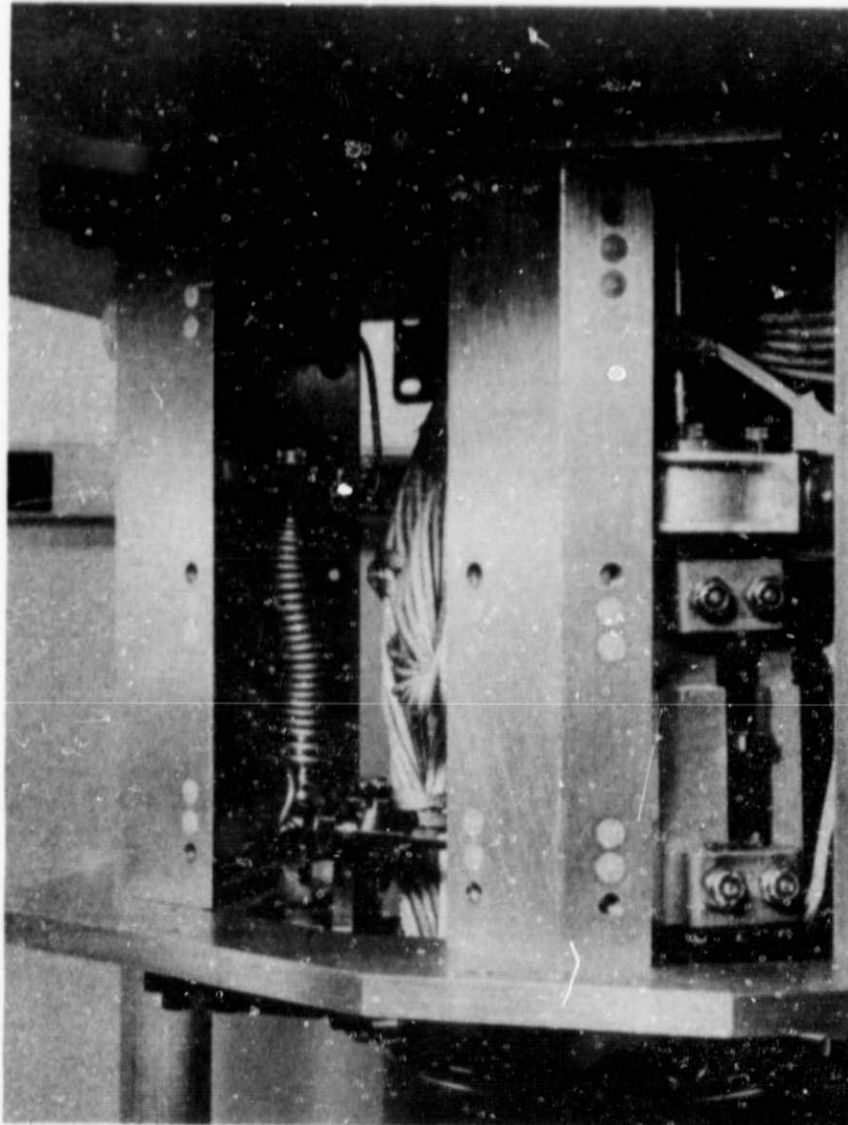
Figures E-37 and E-38 show the gimbal unit with its covers removed for inspection. The appearance is "normal", with no noticeable discoloration. There was no indication of propellant having leaked from any of the feedline connections. Figure E-39 shows the connector side of the gimbal. The 14-pin male connector was somewhat discolored, both on its exterior and the pins themselves. Several tiny mercury droplets were noticed in the cutout region that houses the gimbal pivot.

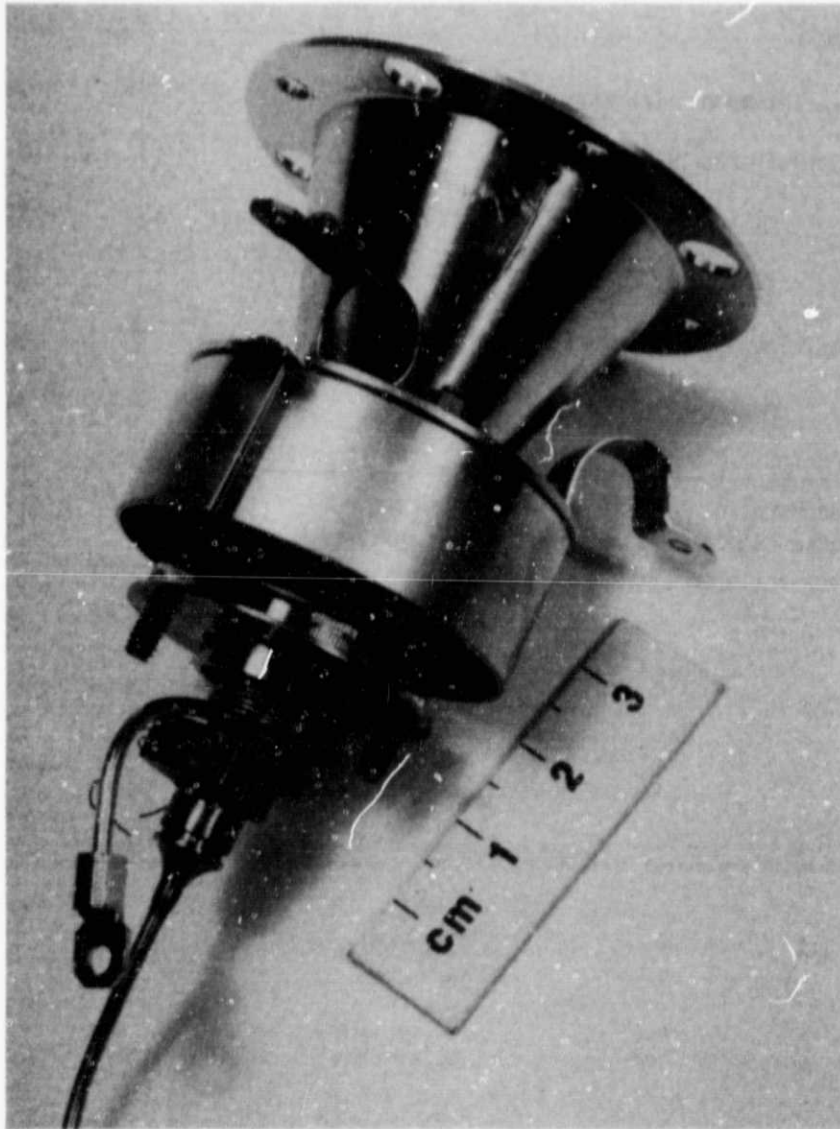
Figure E-40. Post-test C-I-V assembly.

The second disassembly took place after the ionization gage pressure measurements indicated that a mercury vapor leak appeared to be in the cathode isolator. The C-I-V assembly was removed from the thruster and is shown in Figure E-40 with the isolator shield in place. A ball of material can be seen next to the left screw on the flange that is brazed to the isolator. Closeups of the ball are shown in Figure E-41 and E-42. The material appeared to be granular and copper in color. Removing the shield, also disclosed a similar type of material at the downstream end of the isolator. This material followed the

Bubble checks made showed that both of the regions of the foreign material leaked. The region with the ball of material had the largest leak since it had to be sealed with epoxy before the smaller leak could be detected. After cleaning and sealing both regions with epoxy, the assembly was checked with a leak detector and found to be leak tight. The thruster was tested after this cathode isolator assembly was installed. The results of the test are listed in Table E-4; also listed in Table E-4 are the performance acceptance test results made prior to the start of the cyclic endurance test. It can be seen that the thruster performance has nearly attained the original PAT values. The discharge utilizations are identical; i.e.,  $\eta_{dish} = 0.83$ . There is a slight difference in the discharge energies.
